# UHOT Contractor Audit Report

**Site Address:** 11 Wychfield, Westfield

**Remediation Type:** Tank Pull  Remediation

**INCIDENT#:** 19-06-05-1151-57 **PI#:** (if available): \_\_\_\_\_

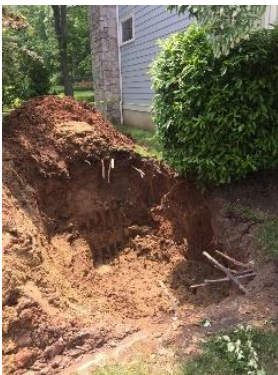
6/5/19 gcharyak received a telephone complaint from Usha, homeowner that Simple tank did not encounter a discharge at the site and a case number should not have been called in. Gcharyak went to the site and met with Jayne Berstein, Realtor. The excavation was open and a 1000gal previously abandoned with sand removed UST. The sand and overburden was staged around the top of the excavation. Some groundwater in the bottom of excavation and some overburden was in the excavation. The base of the excavation could not be observed at the time.
